Ordinary Council Meeting 26 March 2024 Late Attachments

22425.1 - Baryulgil STP Upgrades – Major Works Proposal

Project Title:	22425.1 - Baryulgil STP Upgrades – Major Works
Job Number:	22425.1
Document Title:	Major Works
Date:	15/03/2024
	Quote valid for 14 days

Appendix A. Plumbing Assessment

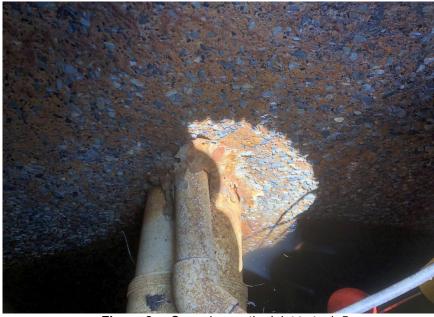
Significant corrosion above operating height, inlet requires re-sealing.

Figure 2. Corrosion on the inlet to tank 5.

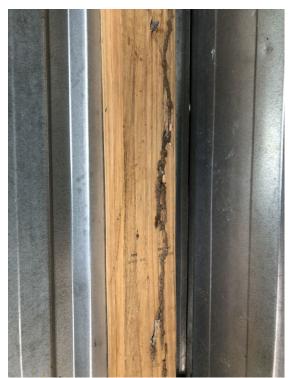
Figure 3. Termite damage within the main control shed.

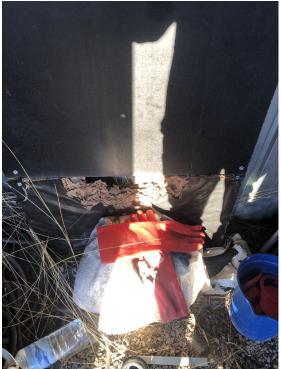
Figure 4. Termite damage and moisture rot damage within the main control shed.

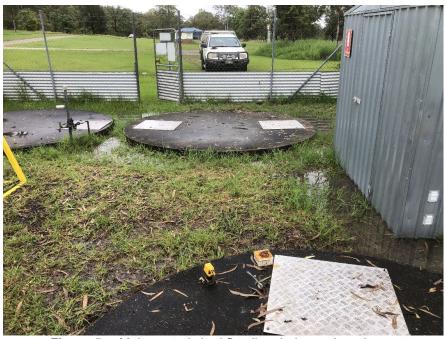
Figure 5. Main control shed flooding during major rain event.

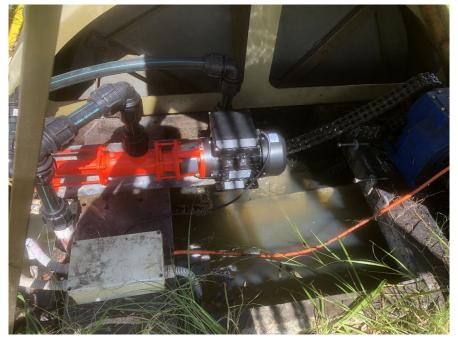
Figure 6. RBC flooded due to electrical issue resulting in high water levels.

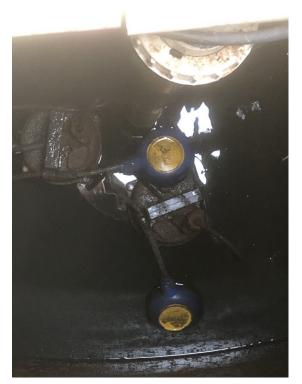
Figure 7. Float tangling due to poor design and limited tank space.

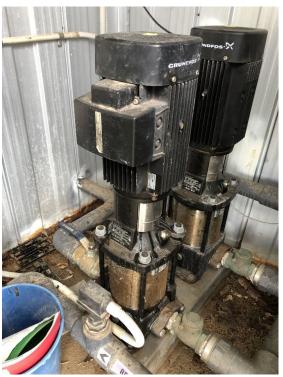
Figure 8. Irriagtion pumps in irriation shed. Note corrosion to the galvanised shed.

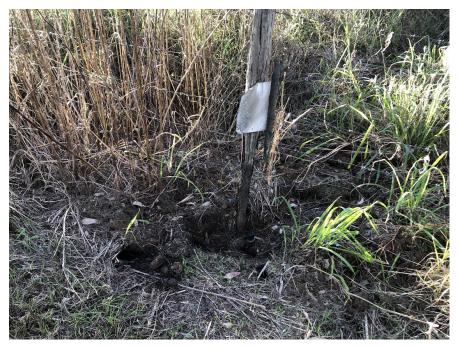
The wet weather dam conveyance line is in poor condition. The line has several raisers that have previously been used as irrigation points (**Figure 12**), these poly raiser have been burnt and would likely leak effluent into the adjacent waterway. The pipe is rural poly, which typically indicates that it is 50+ years old. Ecoteam have been patching multiple leaks found in this line under projects 22268.0 & 22268.1 and expect that the entire length will be failing and leeching effluent into the waterway that separates the STP and wet weather storage dam.

Figure 9. Damaged raiser that has been capped off. This raiser had been burnt and hidden in long grass, testing revealed this pipe is associated with the STP to wet weather dam pipeline. Many more like this have been located and capped.

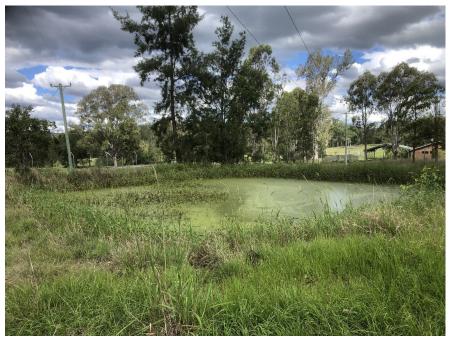
Figure 10. Wet weather dam at high level due to perlonged electrcial control issues plaging the irrigation system.
