Ordinary Council Meeting 26 March 2024 Late Attachments

22425.1 - Baryulgil STP Upgrades – Major Works Proposal

Project Title:	22425.1 - Baryulgil STP Upgrades – Major Works
Job Number:	22425.1
Document Title:	Major Works
Date:	15/03/2024
	Quote valid for 14 days

Appendix A. Plumbing Assessment

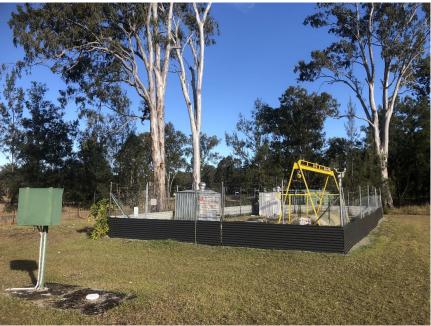
Figure 1. Baryulgil Sewage Treatment Plant.

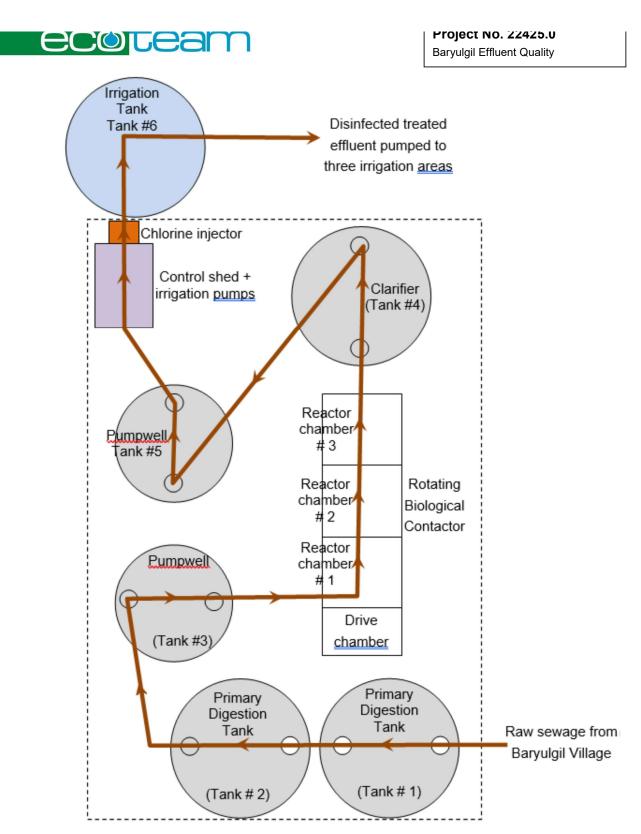
Water samples were collected from the inlet primary digestion tank (tank 1) and the irrigation tank (tank 6) by Cail Cooper on 18 October 2023. Refer to **Figure 1**. Samples were collected using a plastic sample bottle secured to an extendable sampling rod. To minimise the risk of cross-contamination, effluent was sampled first from the effluent irrigation tank (as it was most likely to have lower concentration of analytes) followed by the primary digestion tank. The sample rod was cleaned and disinfected between samples.

Figure 1. Layout of the Baryulgil WWTP
